**Assessment of the stream conditions
associated with the
Hudson Street Gully erosion control works**

CBER Contract Report Number 9

Prepared for the Hamilton City Council

2 July 2001

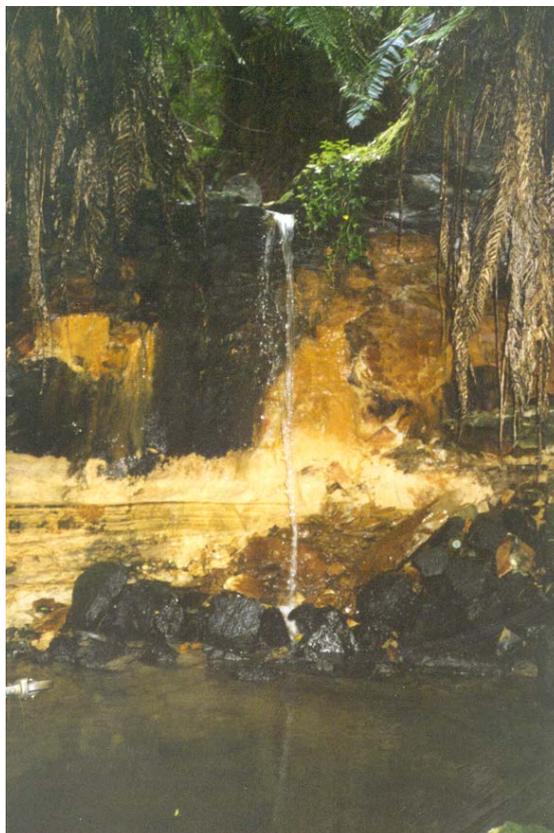
Two stream reaches were electroshocked (Table 1). One section was very short (8.2 m long), and was immediately upstream of the Hudson Street culvert, but downstream of a 2.6-m free-fall waterfall. The waterfall plunged onto a low talus slope at the head of a pool. (Figure 2).

Figure 2. A 2.6-m free-fall waterfall that was 9 m upstream of the Hudson Street culvert. The discharge was 2.35 l s^{-1} when the picture was taken on 26 June 2001 (photo: Brendan J. Hicks).

1. An approximately 3-m waterfall at its confluence with the Waikato River;
2. The 58-m long Hudson Street culvert with its gradient of 0.0143; and
3. A 2.6-m high free-fall waterfall with an overhanging bedrock lip that was 9 m upstream of the Hudson Street culvert.

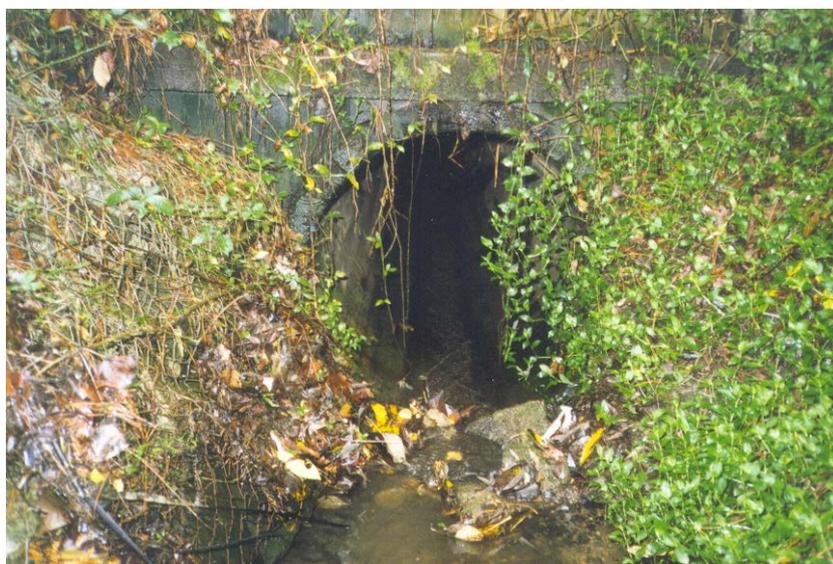
Physical description of the fished stream section. Two stream sections were fished at about map reference NZMS 260 S14 27148 63747. These sections were divided by the 2.6-m waterfall. The upstream entrance to the culvert under Hudson Street was a round concrete pipe with an internal diameter of 1.05-m that had its invert set at stream-bed level (Figure 3). The stream bed between the Hudson Street culvert and the waterfall was angular cobbles and boulders. The stream banks were vertical and were composed of weak sedimentary strata on the waterfall face upstream, capped with a bedrock lip, and gabion baskets overgrown with wandering jew (*Tradescantia fluminensis*) at the sides.

Figure 3. The inlet to the 1.05-m internal-diameter culvert under Hudson Street (photo: Brendan J. Hicks).

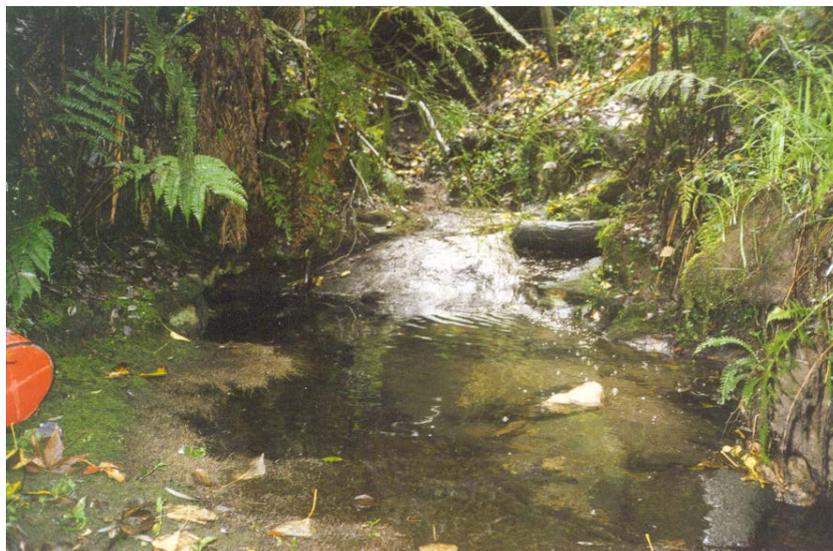
Above the waterfall the Hudson Street Gully Stream was 1-2 m wide with well vegetated margins that created moderate stream shading (Figure 4). The stream banks were mud and clay faces 0.5-1.0 m high that are stabilised by riparian vegetation of shrubs and trees. In places there were undercuts suitable for fish habitat, and tree roots in the stream created additional cover. The riparian vegetation was a mixture of native and exotic species, including a large poplar (*Populus* sp.) and a stand of bamboo (*Bambusa* sp.). The ground cover was mainly exotic weeds such as wandering jew. The stream bed was a mixture of bedrock (10%), sand (50%), mud (45%), and tree roots (5%). The channel was mainly

Figure 4. Hudson Street Gully Stream looking upstream immediately upstream of the 2.6-m waterfall where its discharge was 2.35 l s^{-1} (photo: Brendan J. Hicks).

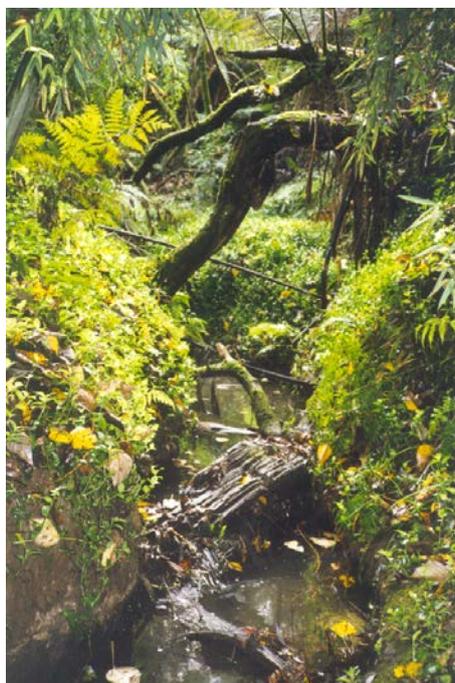
Physical conditions in the upstream reaches. Though our fish survey did not extend more than about 50 m above the Hudson Road culvert, we did walk the stream section up to about 100 m from the waterfall. The stable banks and wooded riparian margins extended throughout this section, and for an unknown distance further upstream (Figure 5).

Figure 5. The Hudson Street Gully Stream beyond the reach in which the fish were surveyed, showing the stable wooded margin and in-stream woody debris (photo: Brendan J. Hicks).

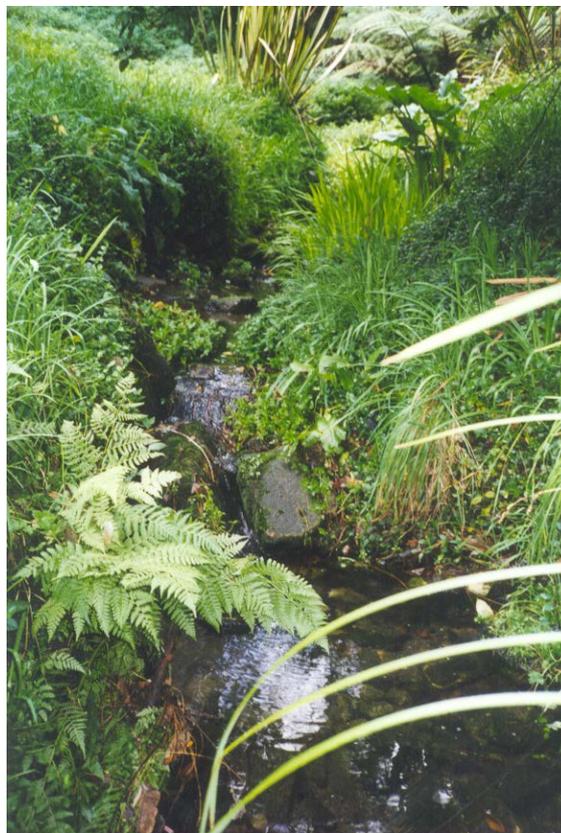
We also walked up the small tributary that joins the main stream from the true left about 25 m upstream of the 2.6-m waterfall. This tributary had a 10-m slope at an angle of about 60° composed of clay, rock, and concrete rubble about 10 m upstream from its confluence with the main stem. Above this slope the stream was about 0.3 m wide with stable grassy margins and a cobble bed (Figure 6).

Figure 6. The tributary on the true left that joins the main stem about 25 m upstream of the waterfall. The discharge on 26 June 2001 was 0.96 l s^{-1} (photo: Brendan J. Hicks).

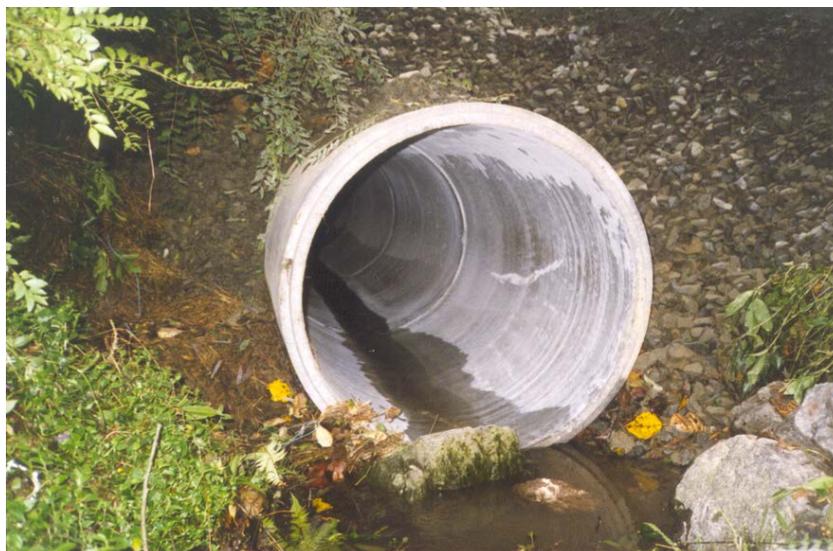
concrete pipe of the same 1.2-m inside-diameter as the shorter culvert upstream (Figure 7). The drop structure from the downstream end of the culvert into the Waikato River had yet to be built at the time of inspection, and was predicted to have a fall of about 1.5-2.0 m to the level of the Waikato River at low flows.

Figure 7. The inlet of the 75-m long culvert on the Hudson Street Gully Stream at a stream discharge of 2.35 l s^{-1} on 25 June 2001 (photo: Brendan J. Hicks).

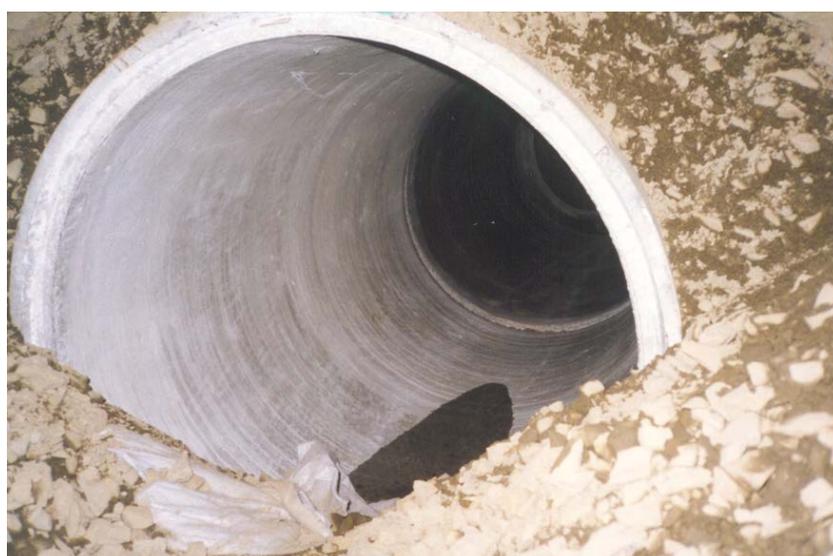
Because the joints in the culvert pipes have not been sealed, at a flow of 2.35 l s^{-1} all of the water that entered the top of the culvert had leaked out before the culvert outlet, making the invert dry for the lower part of its length (Figure 8). The poorly sealed nature of the bed material around the inlet of the culvert may also have contributed to the water loss.

Figure 8. The outlet of the 75-m long culvert on the Hudson Street Gully Stream at a stream discharge of 2.35 l s^{-1} on 25 June 2001, showing complete water loss within the culvert (photo: Brendan J. Hicks).

1. That if the inlet and culvert joints do not quickly seal naturally with fine sediment to limit water loss in the long culvert or at its inlet, they should be sealed artificially to maintain flow through the entire length of the culvert.
2. That the drop structure at the end of the 75-m long culvert should incorporate a ramp with a roughened surface to enable juvenile eels to climb into the culvert regardless of the level of the Waikato River.
