# A catchment scale approach to erosion management: 10 years of the Waipā Catchment Plan

Keri Neilson

Zone Manager Waipā West Coast

Waikato Regional Council

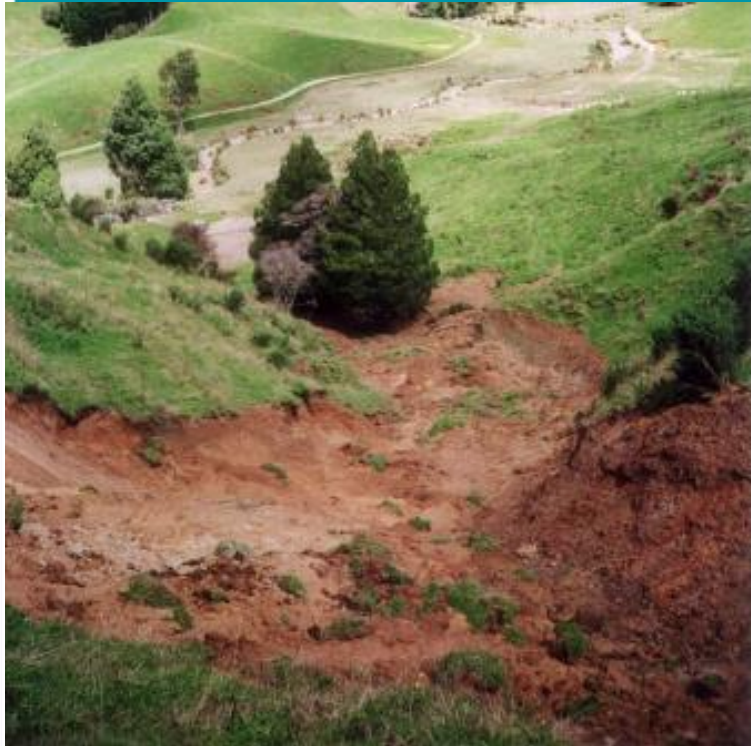
Vulnerability to erosion

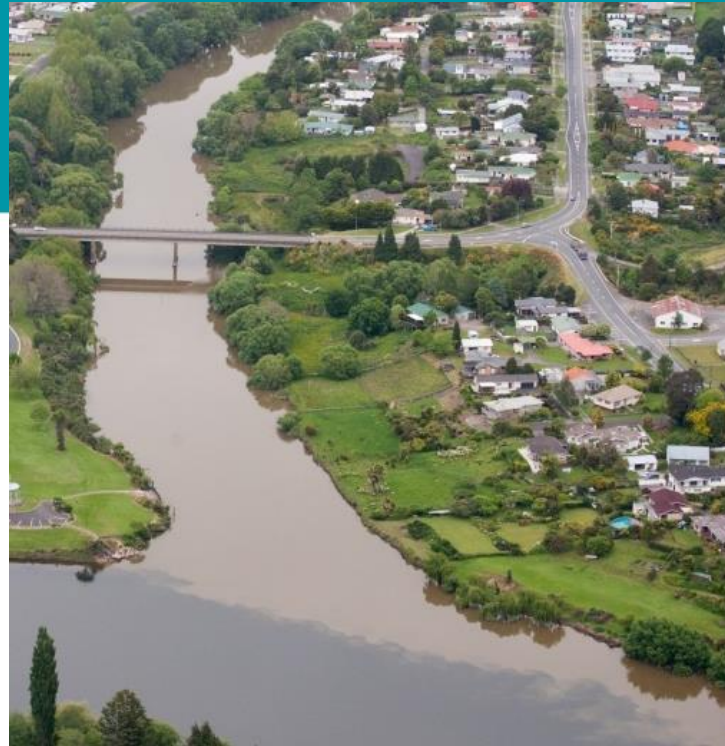
River water quality

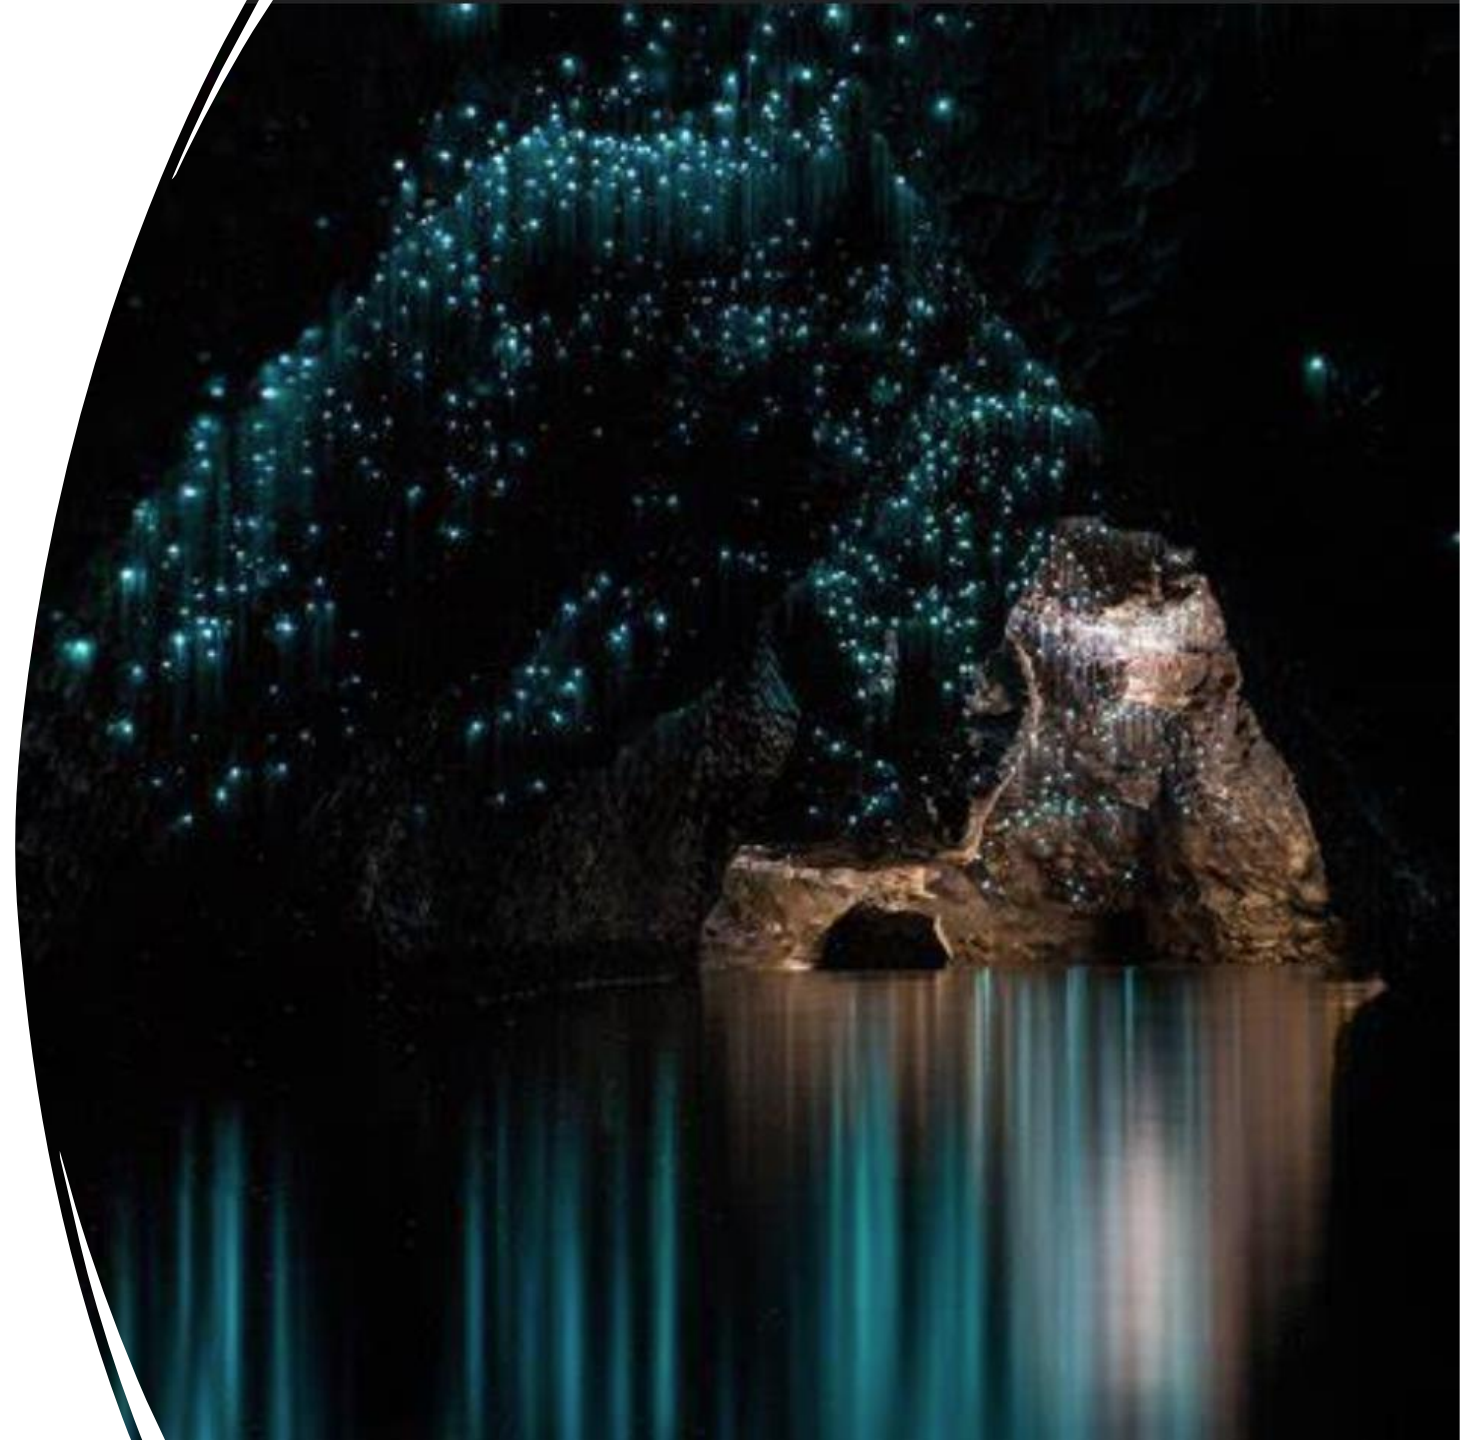
- 1980/90s
- Waitomo Landcare group
- Incentives offered at 75-100%
- By 2014: 118 km of fencing and 1223 ha land retired
- 40% reduction in suspended sediment in Waitomo Stream

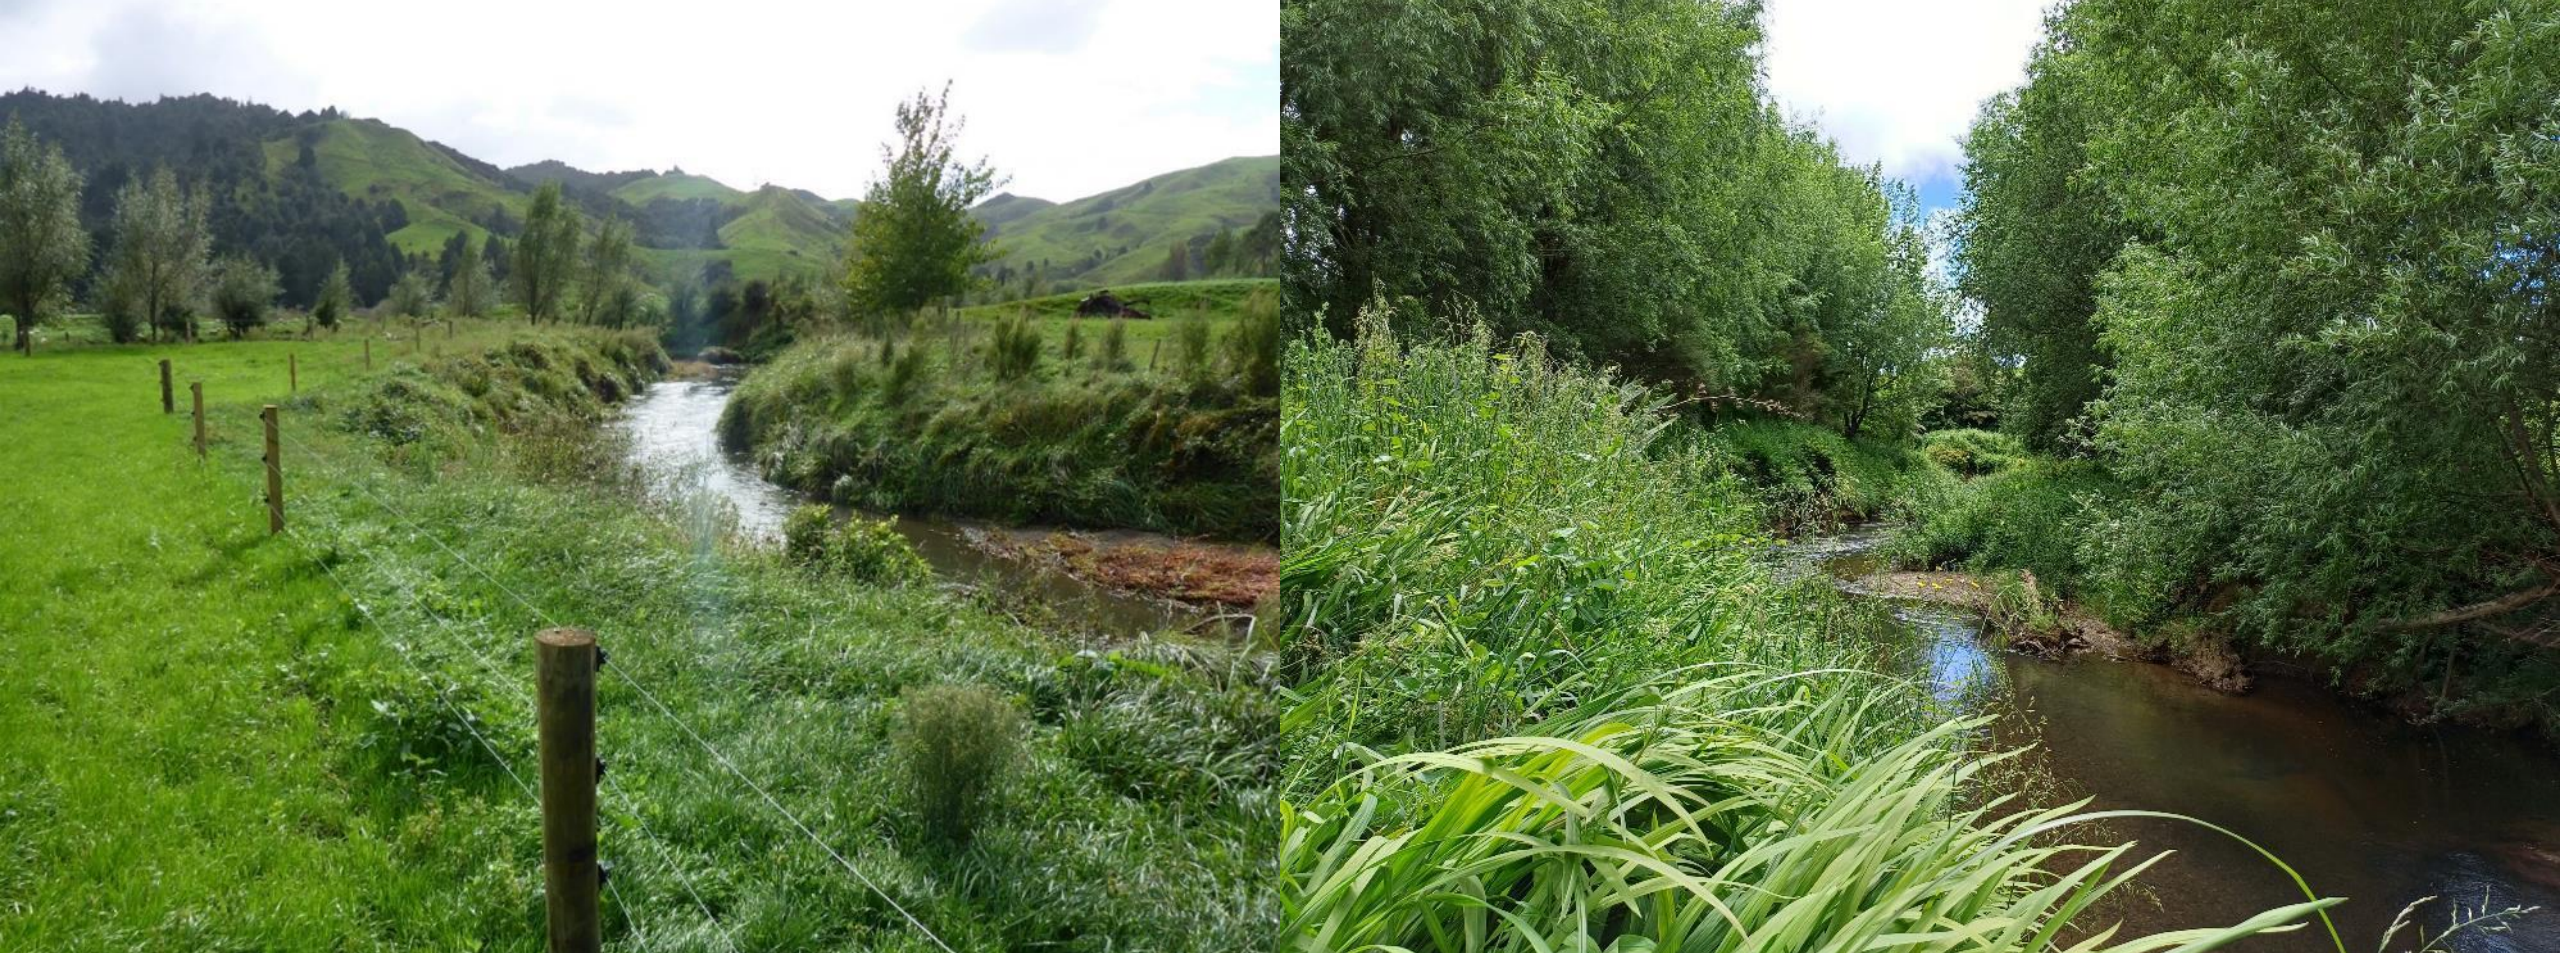
## Kaniwhaniwha catchment gully retirement 2017 and 2022

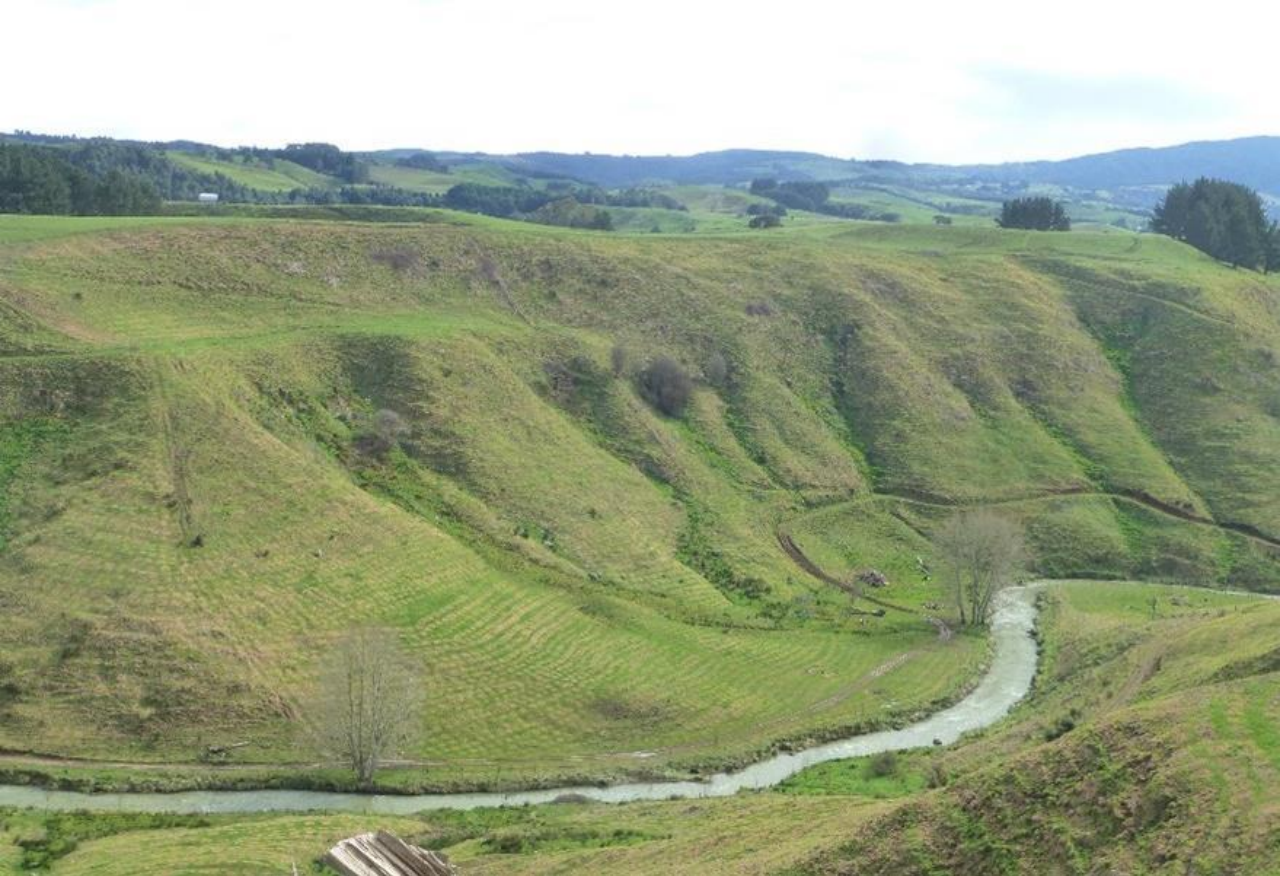
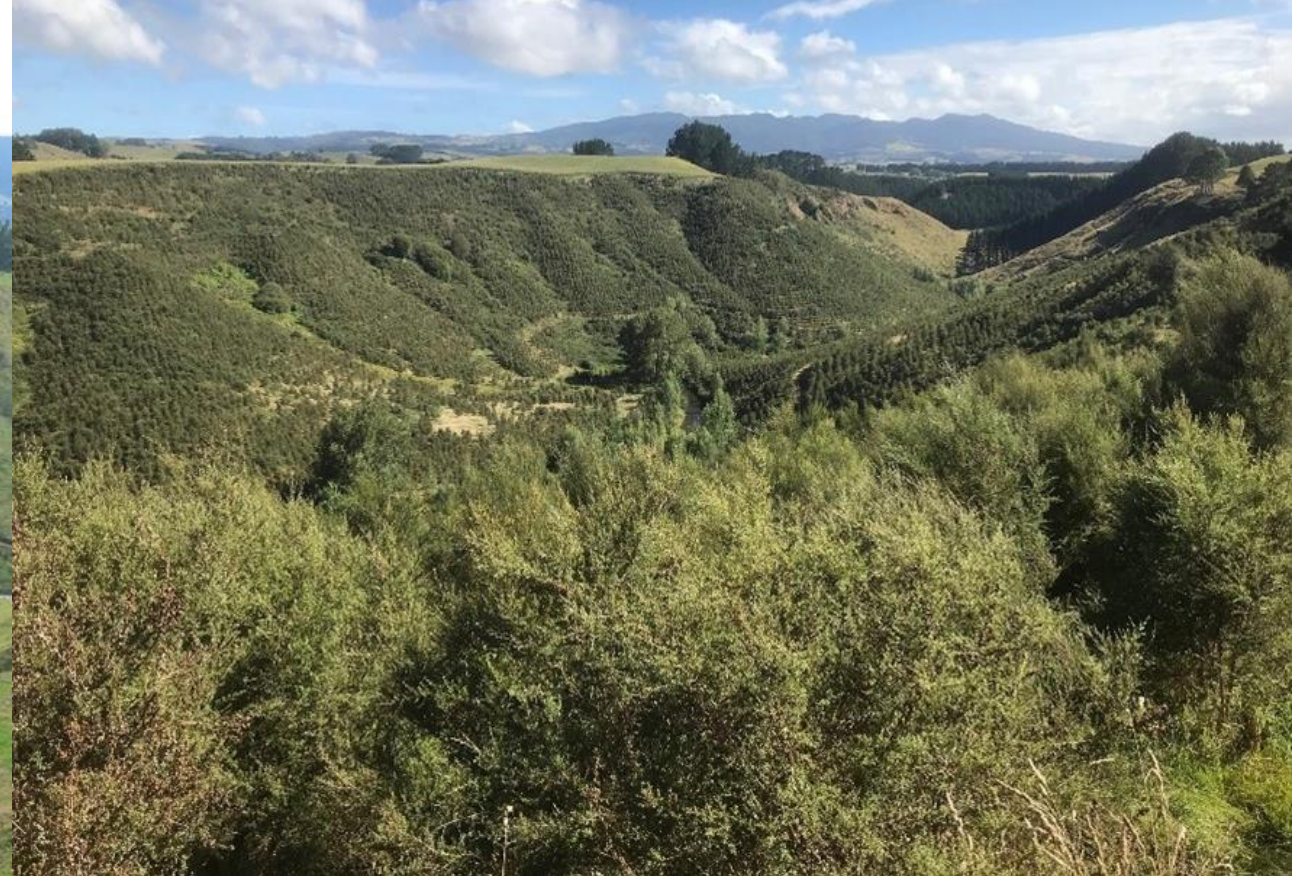
## Kaniwhaniwha Stream restoration 2017 and 2023

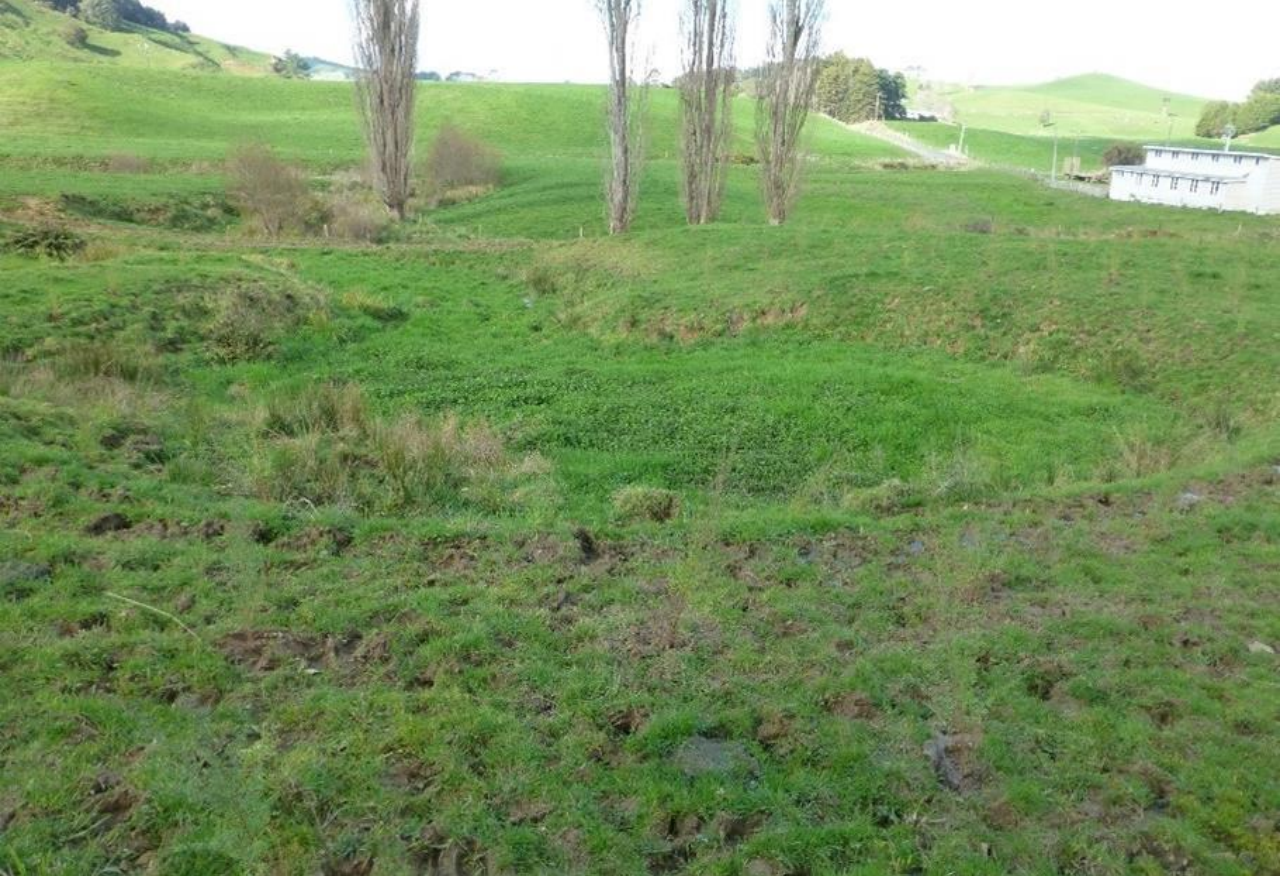
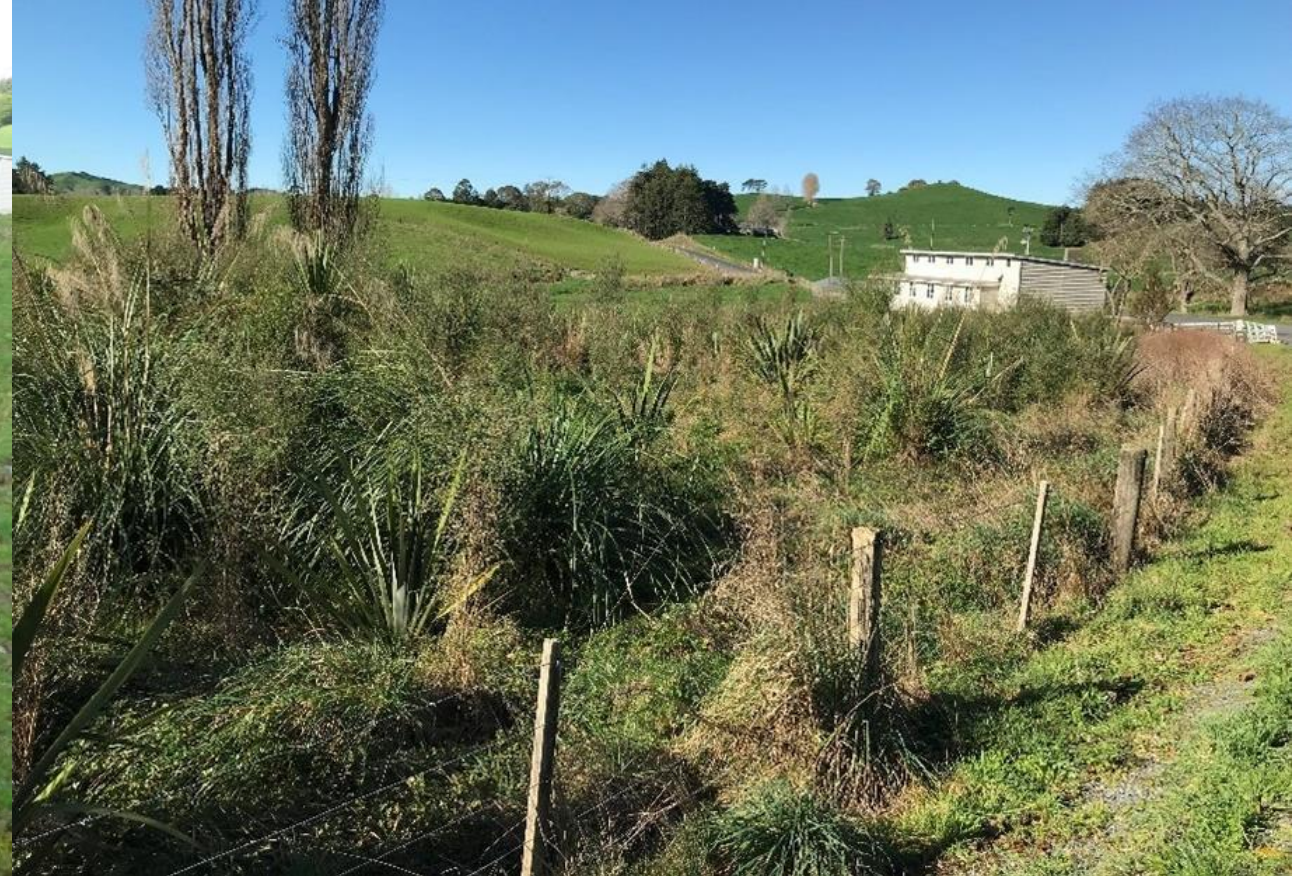
## Moakuraru hill country retirement and revegetation 2018 and 2021

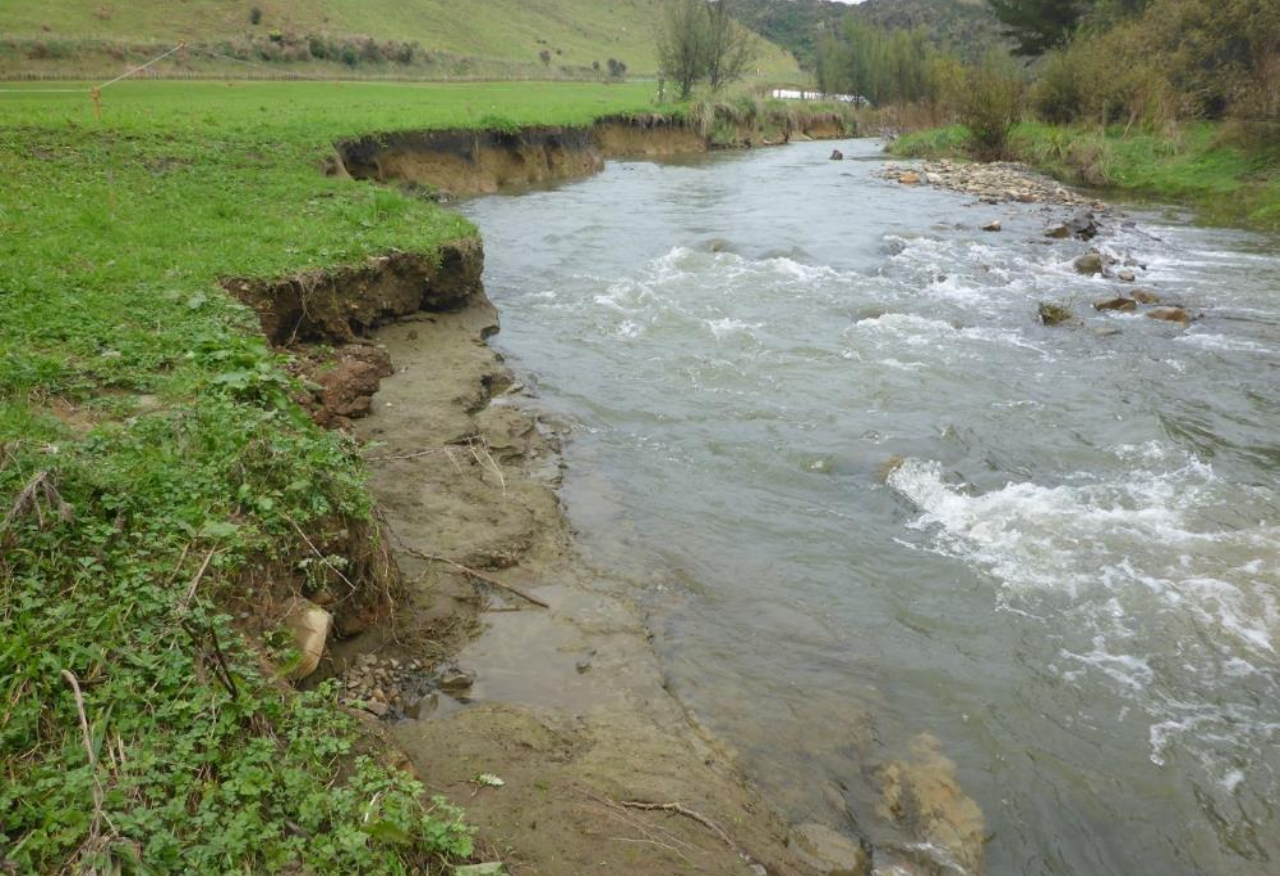
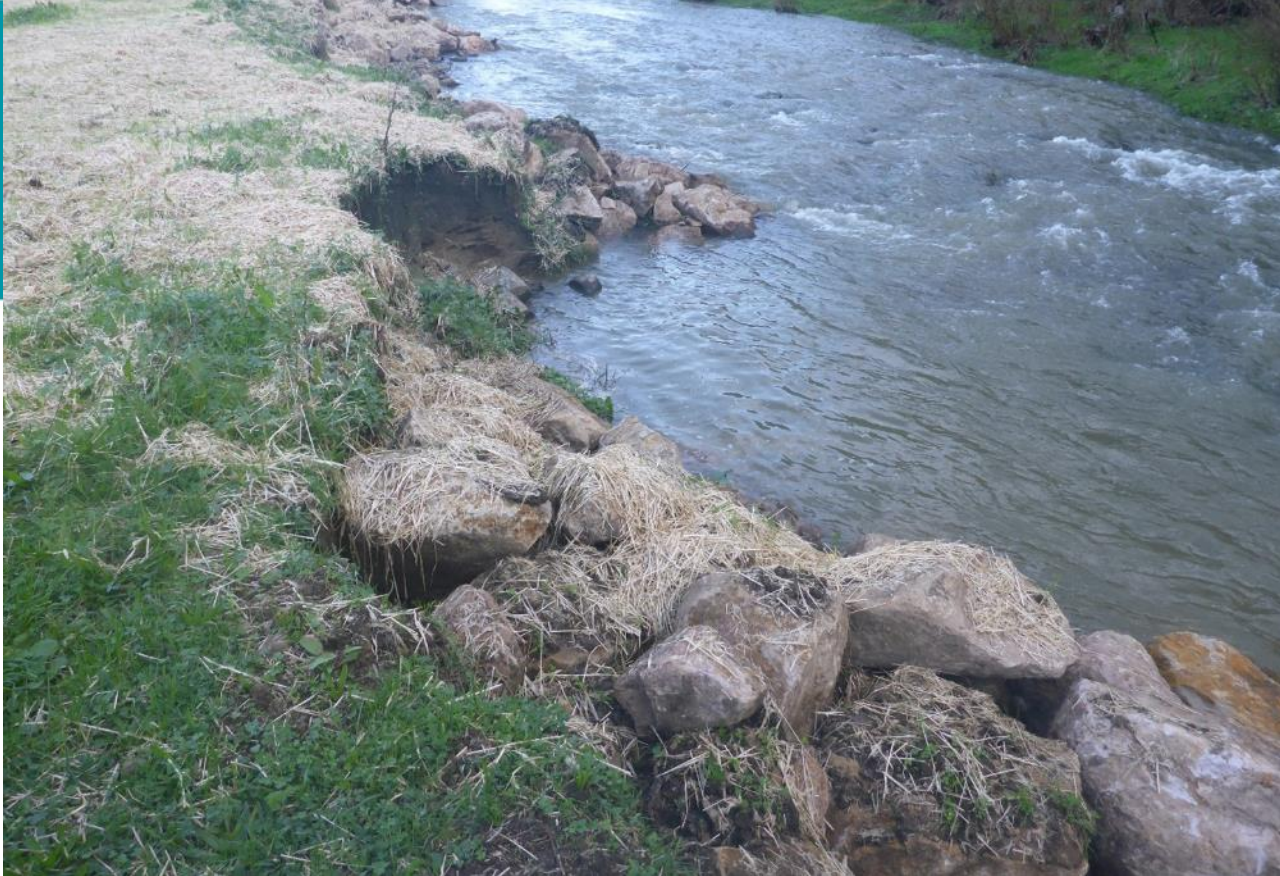
## Moakurarua critical source area retirement 2017 and 2021

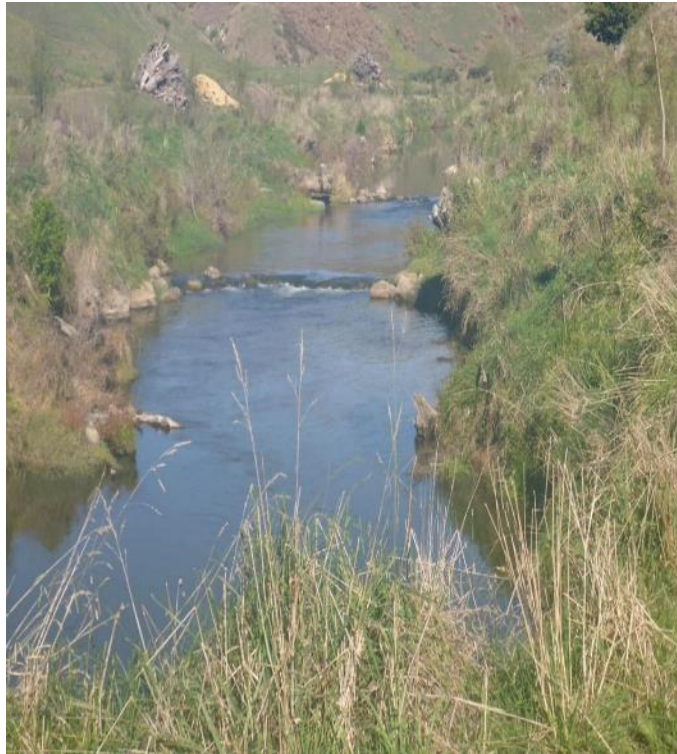
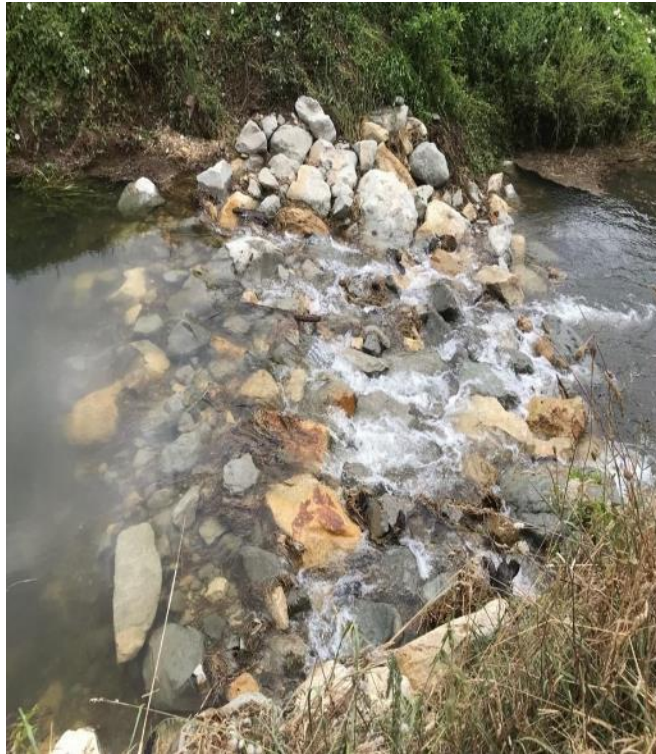
## Erosion control structures to reduce bank erosion

# Erosion control and fish habitat

- Gradient control structures reducing bed degradation and bank slumping
- Designed to provide habitat diversity for fish

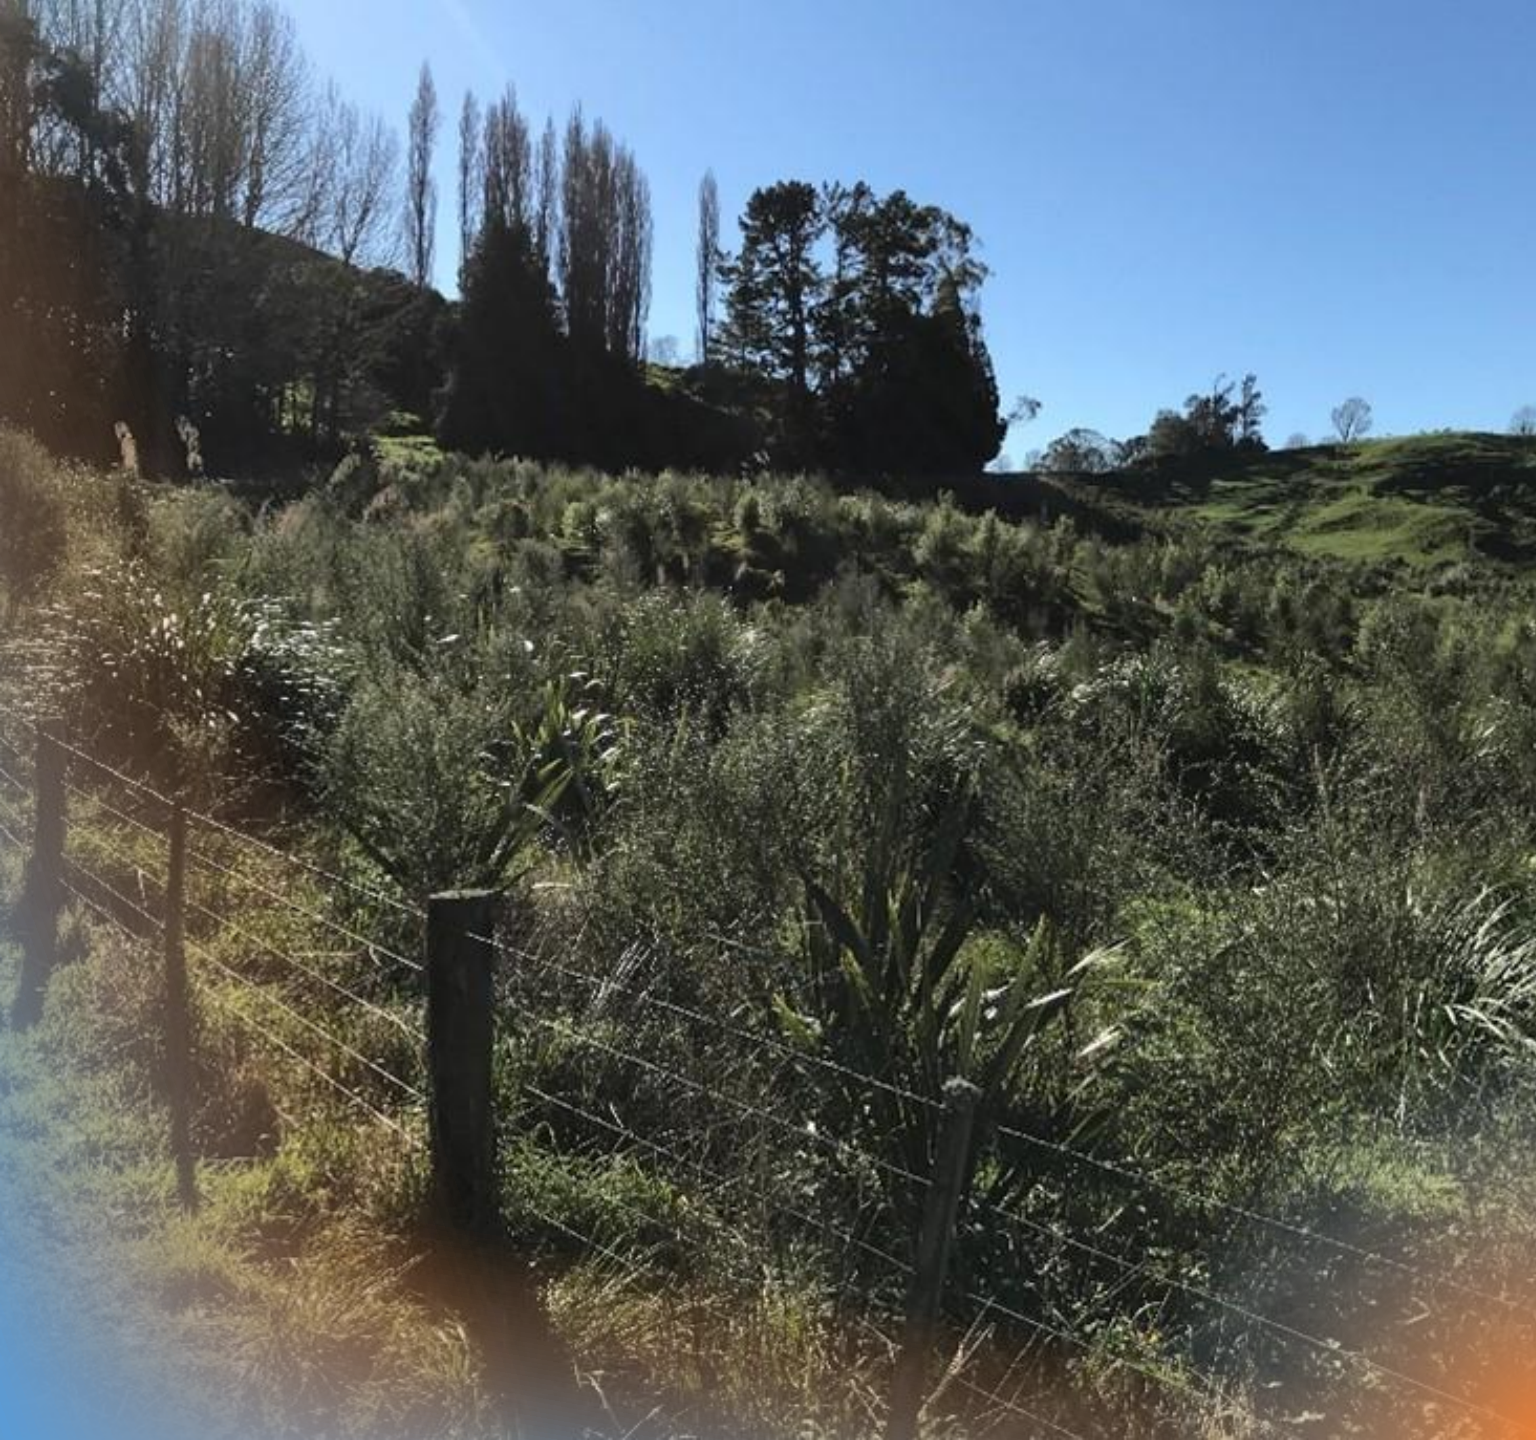
- Kaniwhaniwha
  - Length of fenced streambank increased from 49% in 2017 to 65% in 2022
  - Approximately 85% of the surveyed bank length stable with no evidence of erosion
  - Eroding bank length has decreased over time but difference not yet statistically significant
