**Assessment of the stream conditions
associated with the
Hudson Street Gully erosion control works**

CBER Contract Report Number 9

Prepared for the Hamilton City Council

2 July 2001

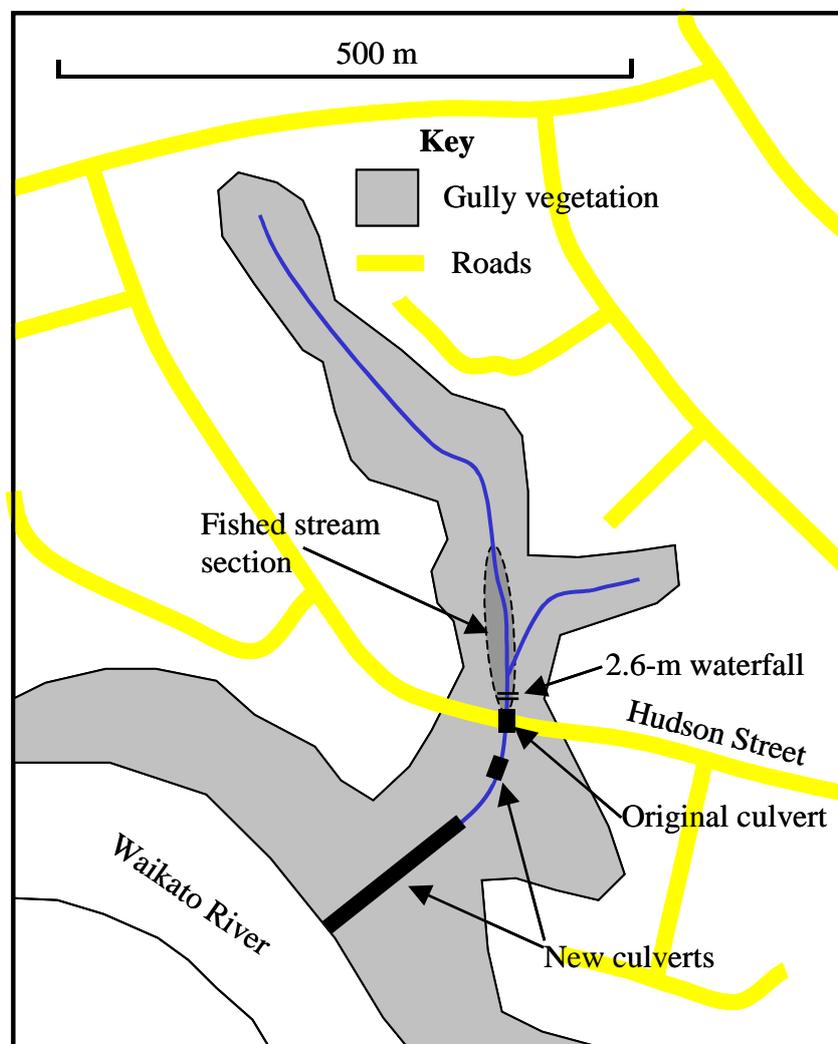
Figure 1. The location of the new and existing culverts on the Hudson Street Gully stream, showing their relation to the fished stream section and the gully vegetation.
